May 23, 2023

RE: *Perform a site visit to Determine the Preferred Building to Renovate into a Safe House (Located at):* Akiachak, Alaska

Kuna Engineering (Kuna) appreciates this opportunity to provide Alan Michael, LLC with a Site Visit Report on the above referenced project.

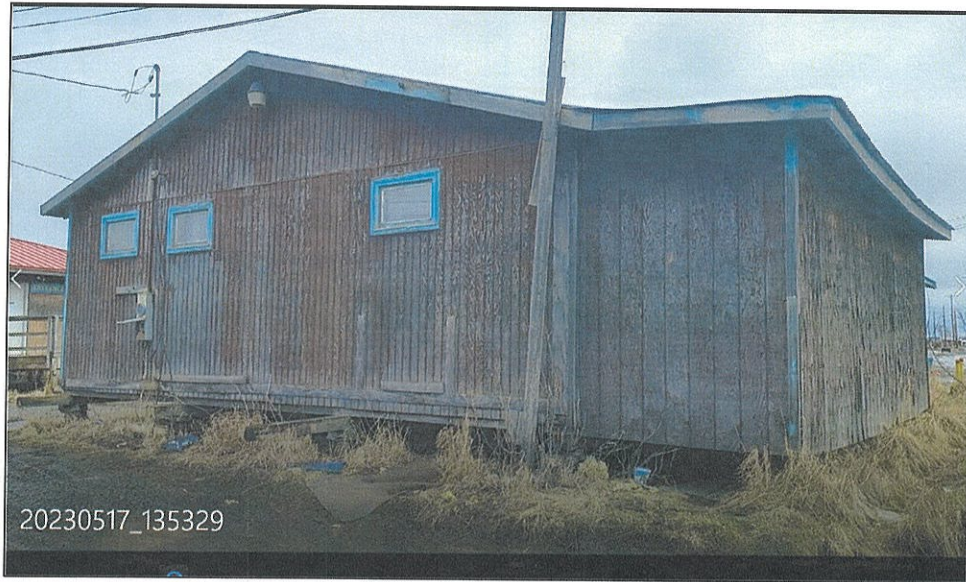
Site #1

there were leaks in the roof, exterior walls were in disrepair, and the main entry was not safe to walk on due to rotting sub-floor. Mold could be smelled throughout the interior. Interior finishes were compromised due to neglect, mold, and damage from vandalism. The entire space was left abandoned with piles of furniture, files, miscellaneous building materials, trash, and equipment strewn about and did not allow for proper analysis of overall flooring and structural condition. However, where footing was possible, the main floor did not seem to be soft to the foot. It was reported that this building had its asbestos removed.

IRA Building – Exterior Deterioration

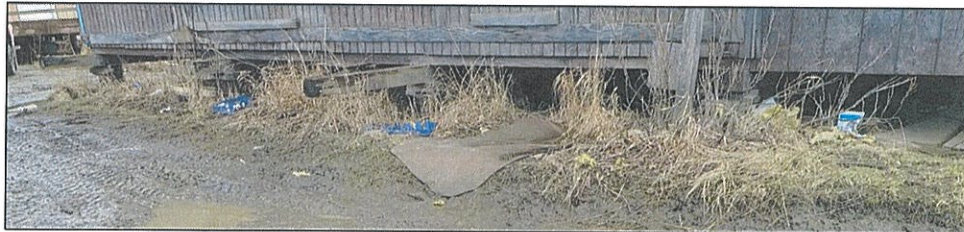
Site #1

The perimeter pilings were barely visible due to high thaw-water and mud. It was apparent that the pilings were in various states of deterioration and in some cases appeared to be shored-up with additional light gage wood dunnage. There were no apparent structural connections from the pilings to the floor beams.

IRA Building – Shoring on top of piles

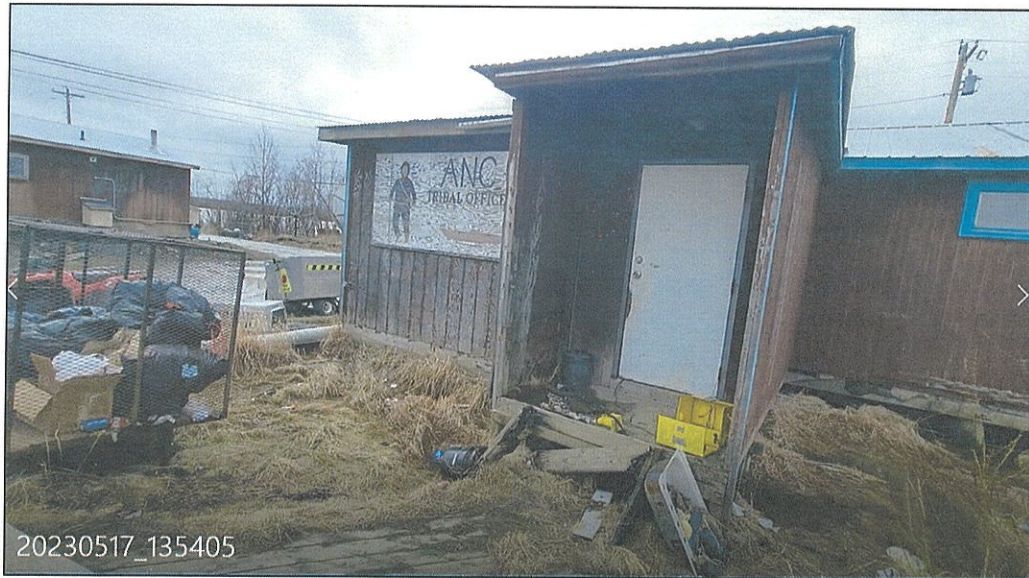
Site #1

IRA Building – Exterior Deterioration

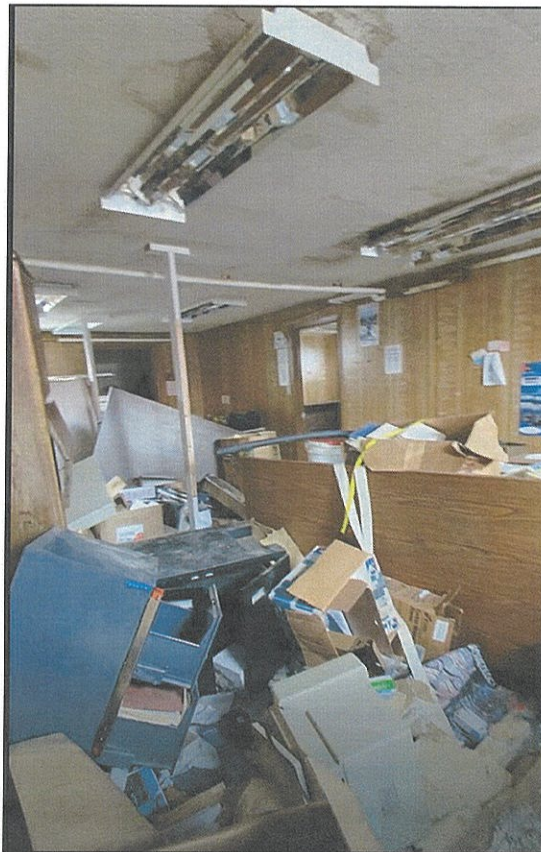
Site #1

IRA Building – Damaged Ceiling

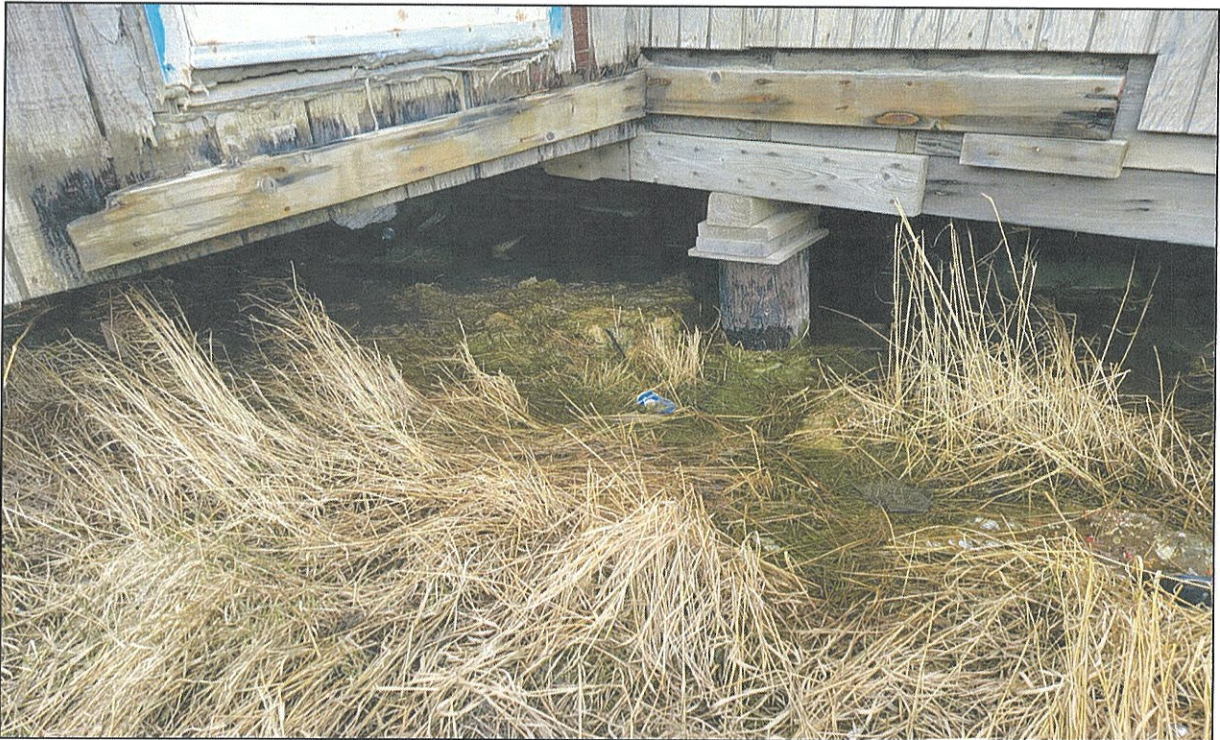
Site #1

IRA Building – Wood sleepers above wood pile

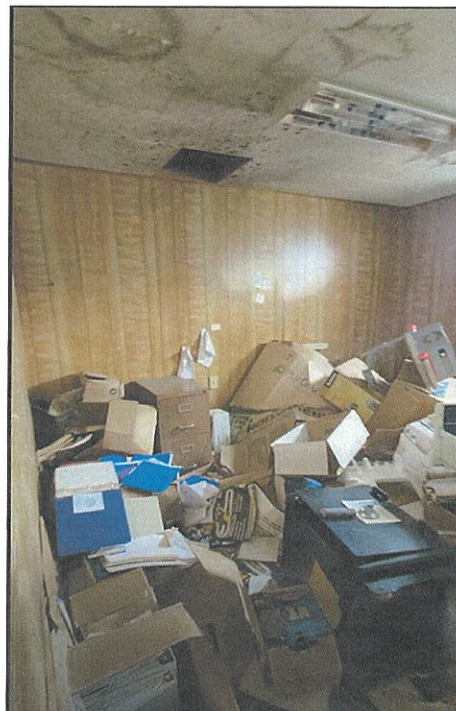
Site #1

IRA Building – Water damaged ceilings

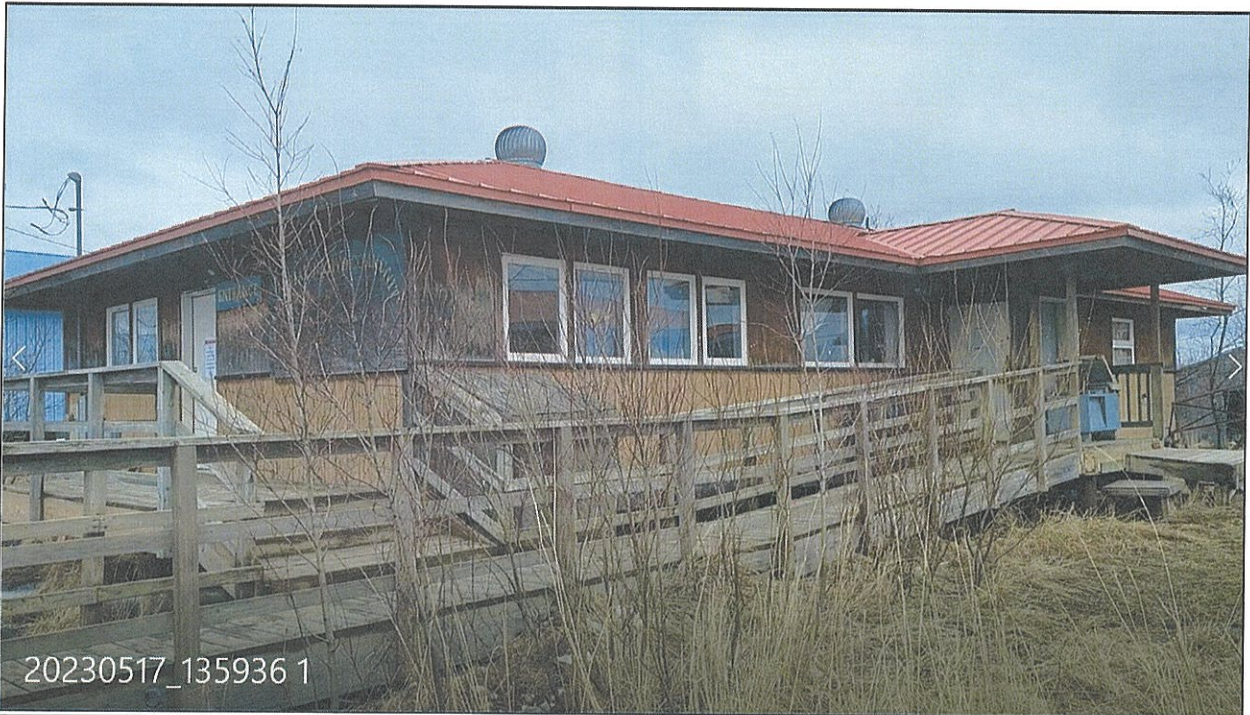
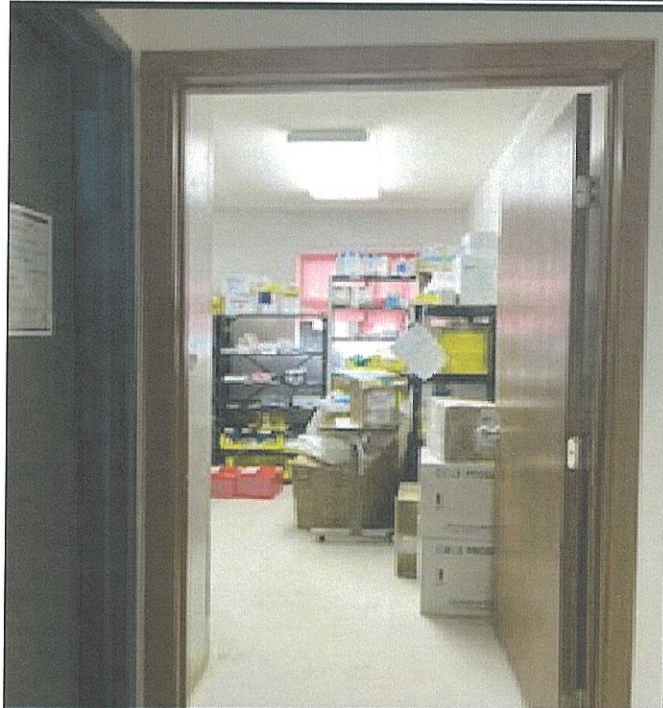
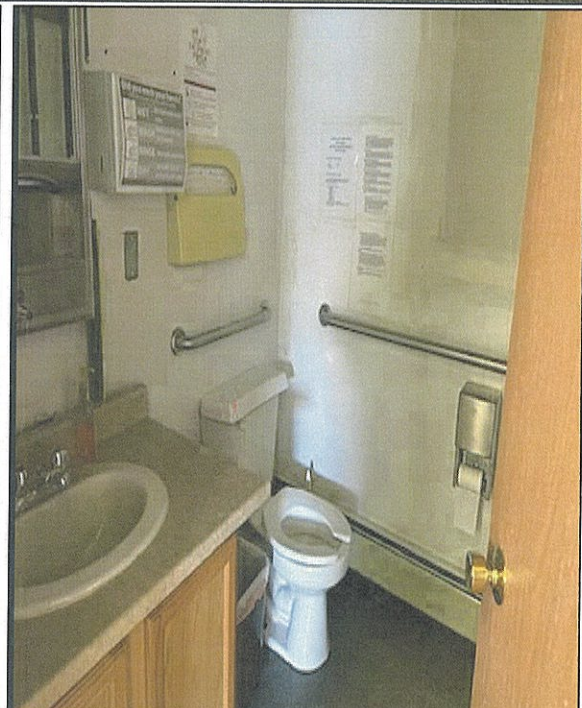
Site #2

The second site visit was the currently occupied health clinic. The building is approximately 2,100 square feet and appears to be in fair to good condition. No apparent serious structural, architectural, or systems deteriorations were evident. The building's foundation sits atop cylindrical steel piles. The current occupants are scheduled to relocate their operation to a facility under construction and should be available for move-in late summer or early fall 2023. The nearest structure is approximately 40 feet to the west.

Community Clinic – Fair Condition

Because this building's foundation, envelope, and interior are in fair to good shape and will be vacant sometime later this year, it is our recommendation to look closer at renovating it to accommodate Safe House operations for the community. The building program is not yet well-defined. However, based on preliminary discussions with the program director, it is likely that a good portion of the physical program spaces can be accommodated therein. However, the function of the space, i.e., clinic versus residential safe house use is different. Thus, more than 50 percent of the interior walls, plumbing, heating, and finishes require renovation which will mandate the structural analysis of the building to comply with the code. The new modifications must meet the minimum requirements for a Level 3 alteration according to the Existing Building Code adopted by the State of Alaska. If there is a need to expand the existing footprint, a small expansion may be possible to the west; or if the existing IRA Building were demolished, larger expansion space could be realized to the south.

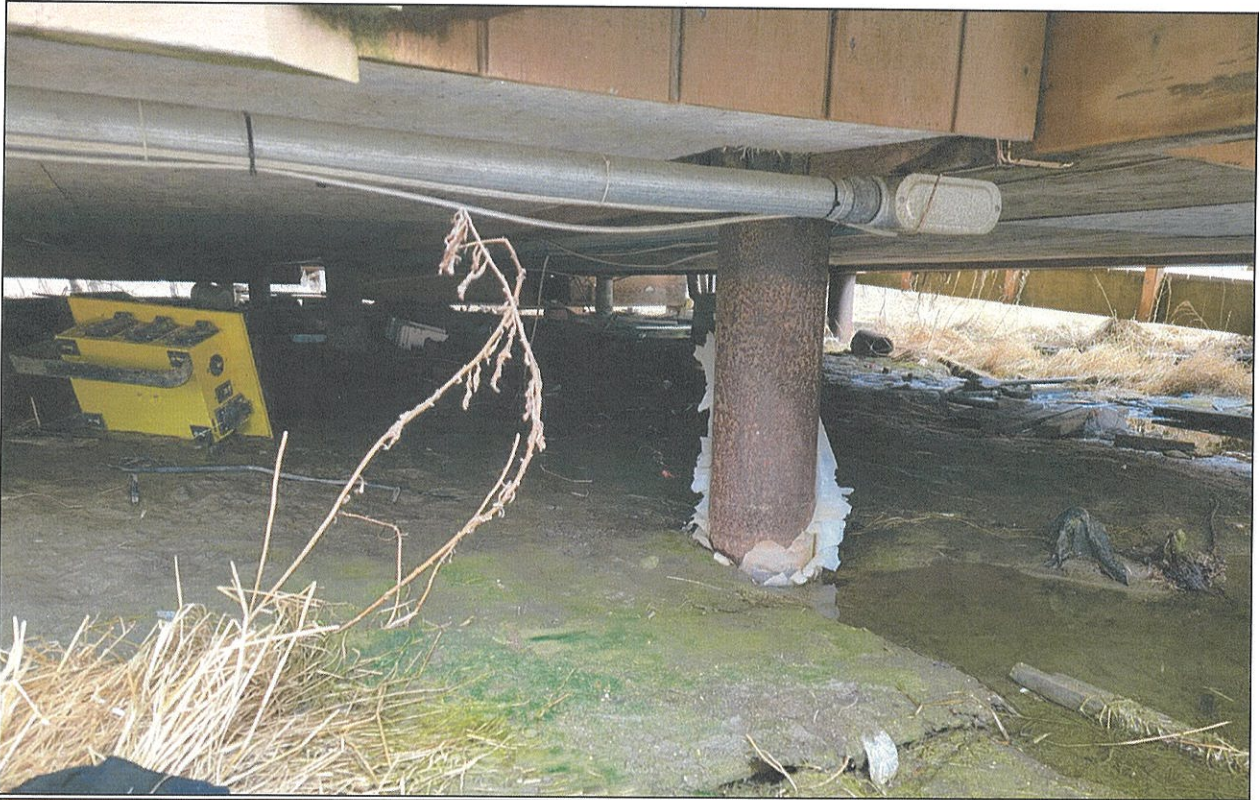
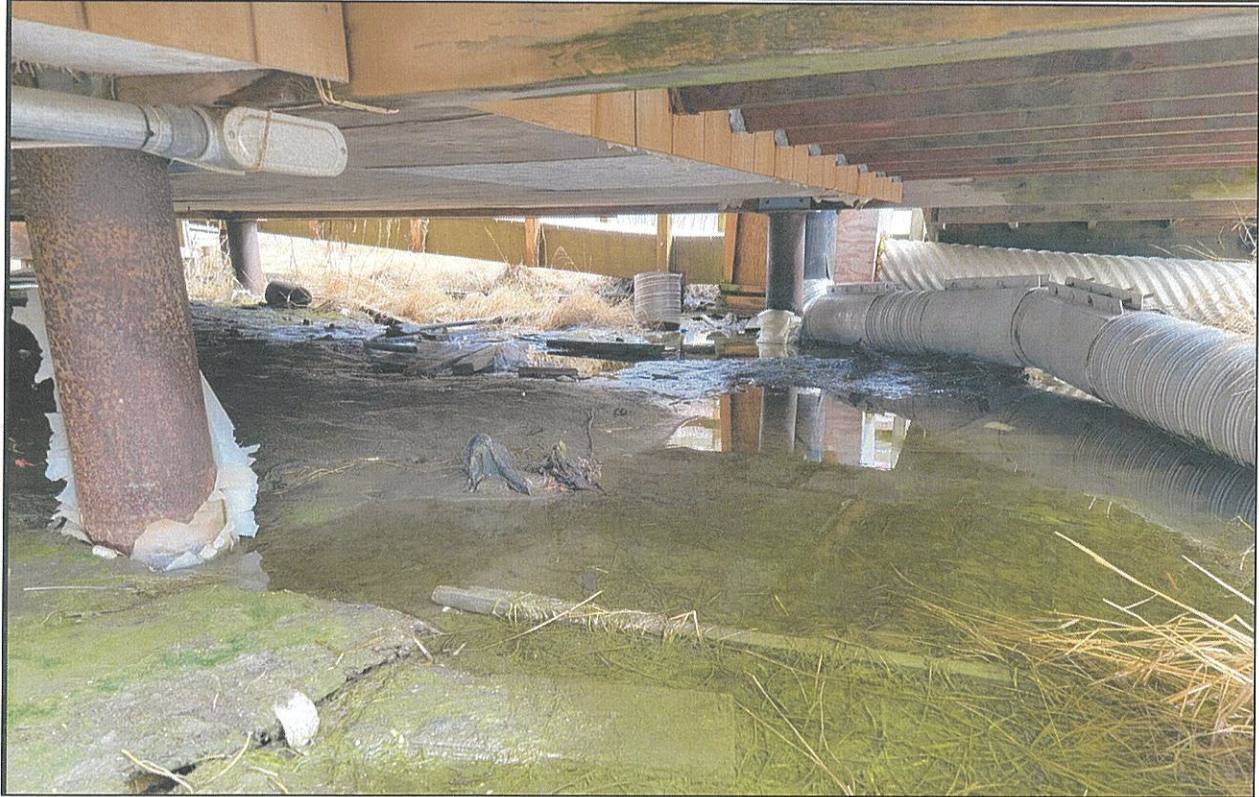
Site #2

Community Clinic – Steel piles

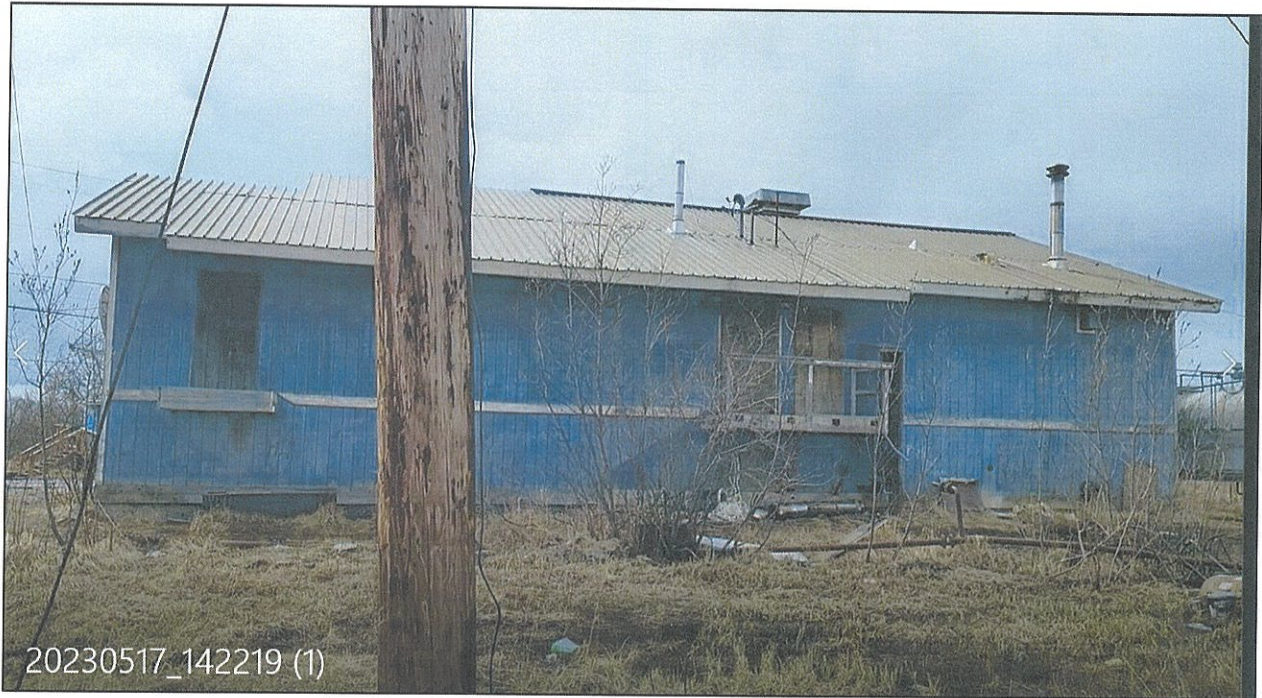
Site #3

The third site visit was the old washateria building that has also been similarly abandoned to site one but is not safe to enter. No further analysis of this site was possible.

Old Washeteria – Damaged (Not Accessible)
