FINAL GEOTECHNICAL REPORT

SECOND AND THIRD STREET REHABILITATION PROJECT

Manokotak, Alaska

Bristol Project No. 32150007

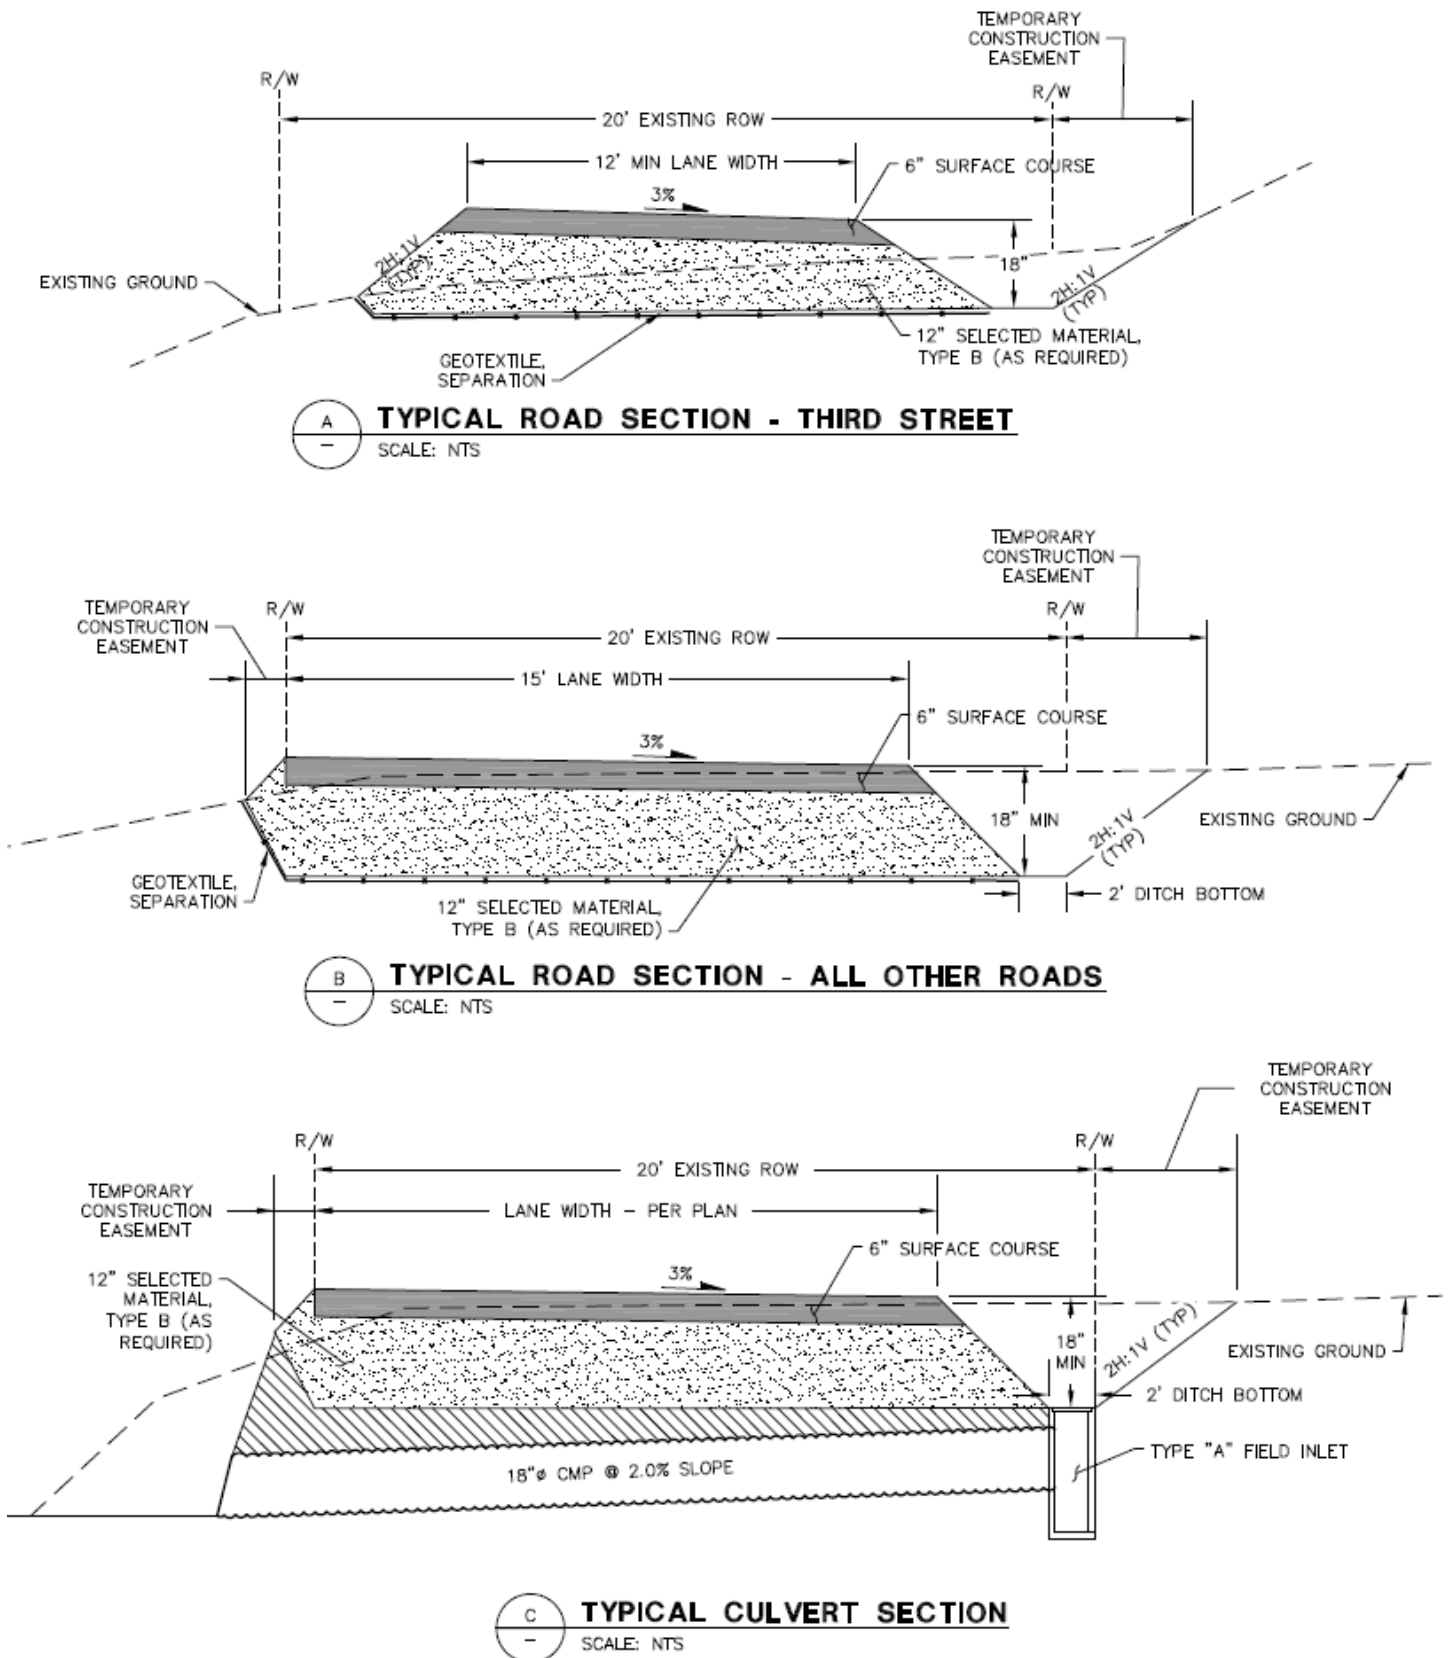
Figure 3 - Typical Road Sections

construction loading scenario. See Appendix D for design calculations and Figure 3 for recommended typical road sections.

Table 2 Roadway Structural Section

Minimum Thickness (inch)	Material
-	Calcium Chloride, Dust Palliative
6	E-1 Surface Course
12	Select Material – Type B
-	Geotextile Fabric
-	Existing Native Material

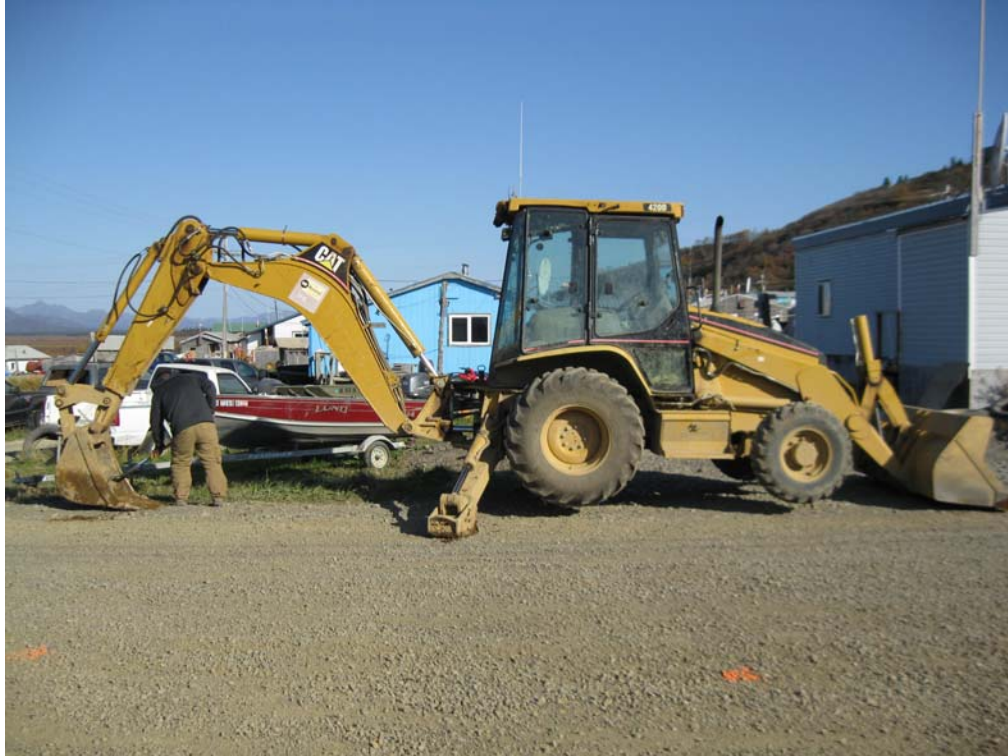
Photo 1 - CAT 420D Wheel Loader

During the field activities, Bristol contracted The City of Manokotak, who provided a CAT 420D Wheel Loader to excavate seven test holes along the proposed road alignments. Graphical exploration logs are included in Appendix B.

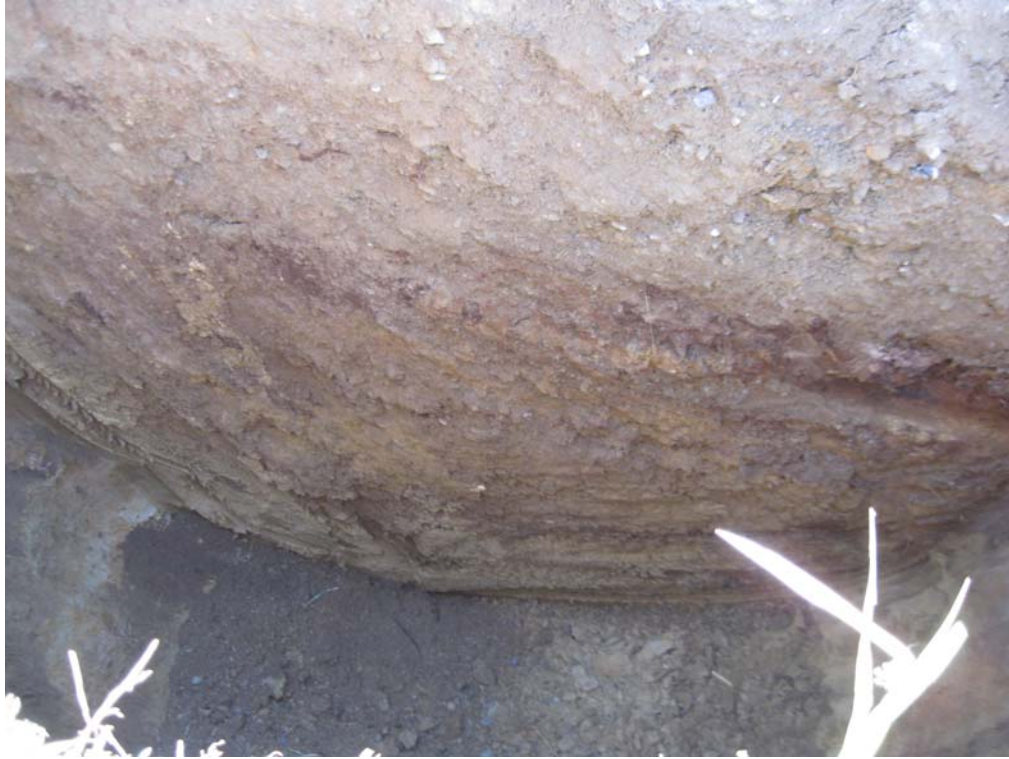
Photo 3 - TP-1 Soil Profile

The in-situ excavation revealed dry silty gravel with sand to a depth of 1.5 feet, underlain by dry organic silt to a depth of 2.0 feet, underlain by moist silt to the bottom of the excavation at 5.0 feet. No groundwater was encountered.

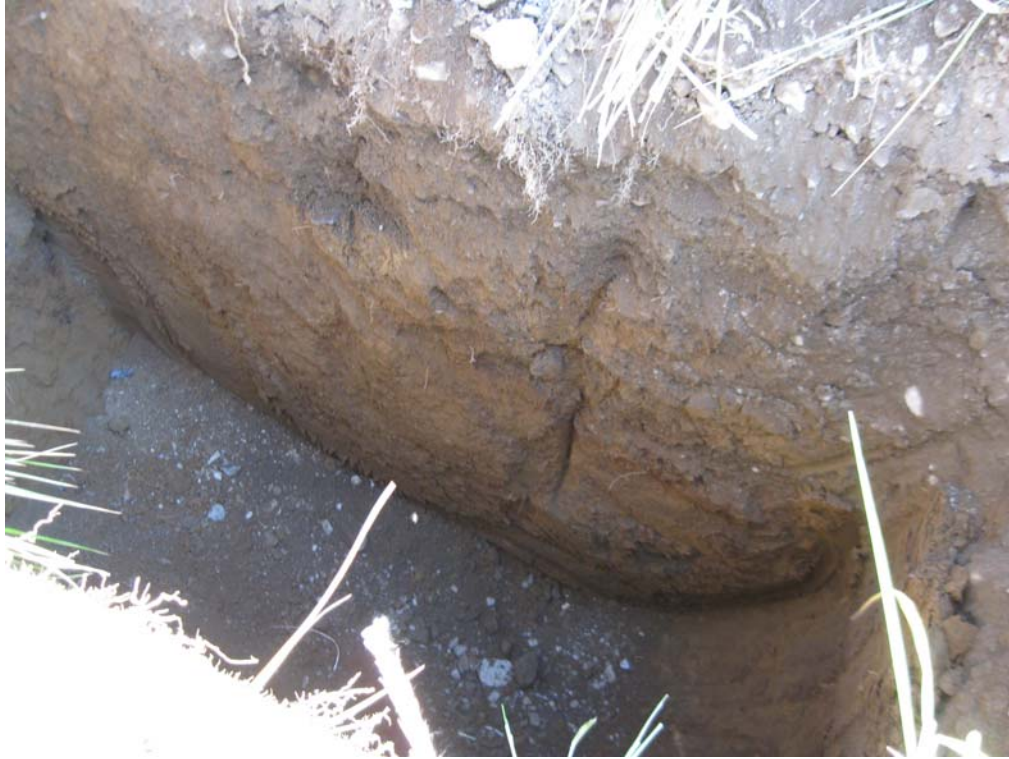
Photo 7 - TP-2 Soil Profile 5' BGS

The in-situ excavation revealed dry silty gravel with sand to a depth of 1.0 feet, underlain by moist silt to the bottom of the excavation at 5.0 feet. No groundwater was encountered.

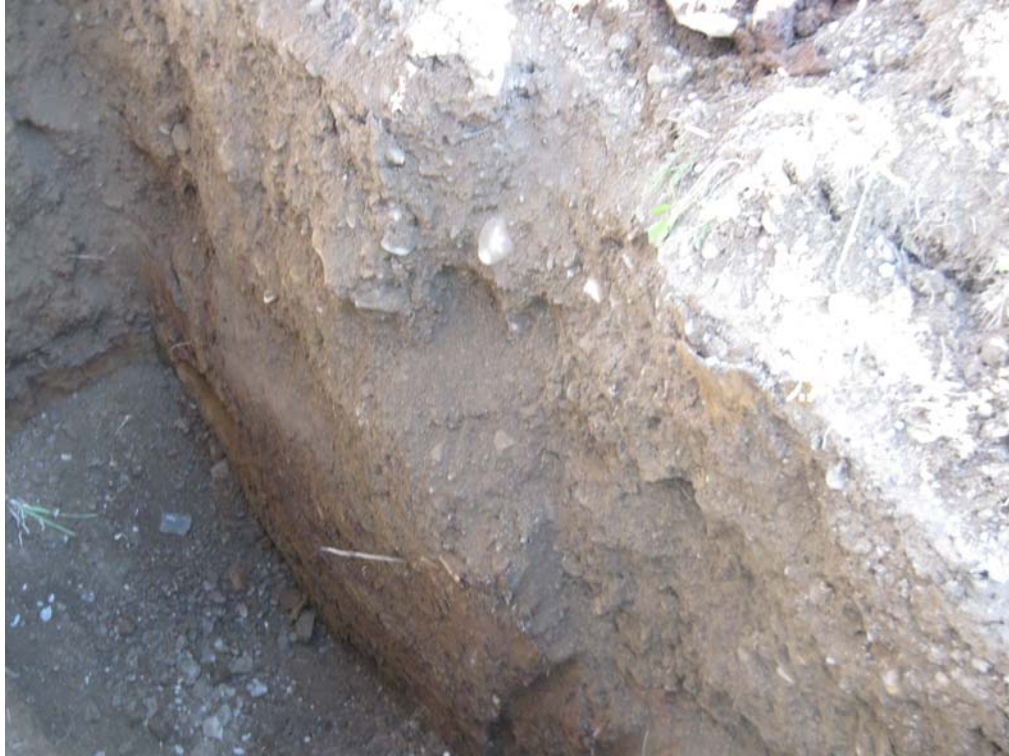
Photo 11 - TP-3 Soil Profile 5' BGS

The in-situ excavation revealed dry well graded sand with silt and gravel to a depth of 3.0 feet, underlain by moist silt with sand to the bottom of the excavation at 5.0 feet. No groundwater was encountered.

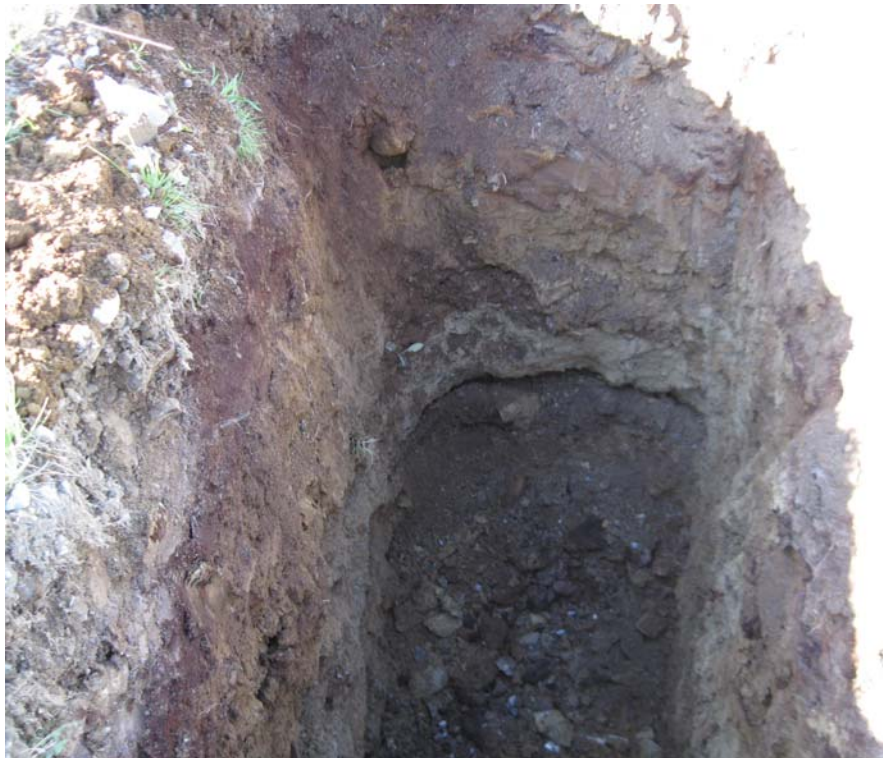
Photo 14 - TP-4 Soil Profile 5' BGS

The in-situ excavation revealed dry silty gravel with sand to a depth of 0.5 feet, underlain by dry organic silt to a depth of 1.0 feet, underlain by moist silt to the bottom of the excavation at 5.0 feet. No groundwater was encountered.

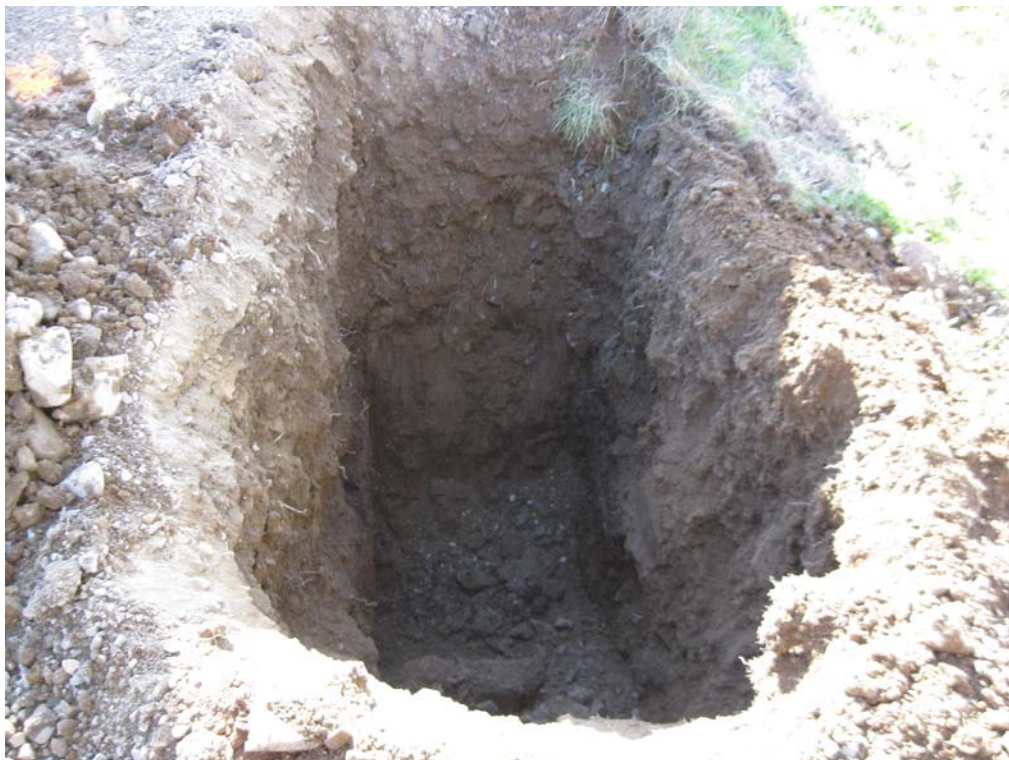
Photo 18 - TP-5 Soil Profile 5' BGS

The in-situ excavation revealed dry silty gravel with sand to a depth of 2.5 feet, underlain by moist silty gravel to the bottom of the excavation at 5.0 feet. No groundwater was encountered.

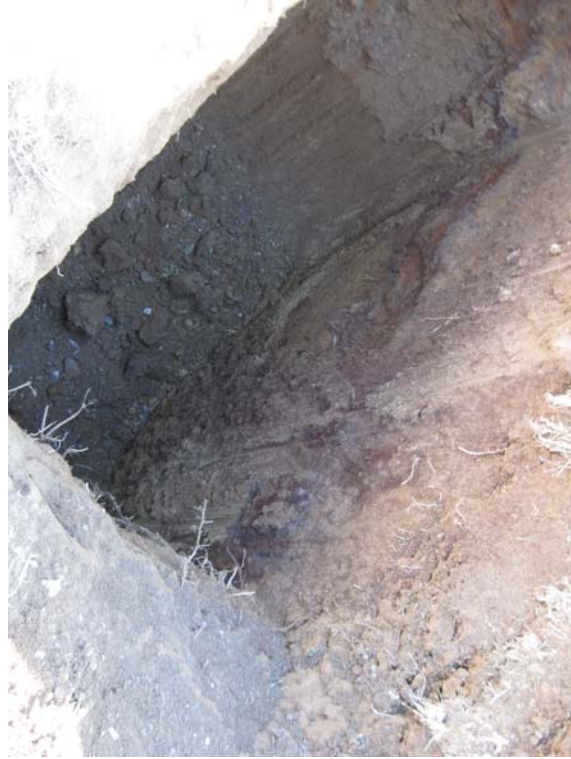
Photo 21 - TP-6 Soil Profile 5' BGS

The in-situ excavation revealed dry silty gravel with sand to a depth of 0.5 feet, underlain by dry organic silt to a depth of 1.0 feet, underlain by dry brown sandy silt to a depth of 3.0 feet, underlain by dry white sandy silt to the bottom of the excavation at 5.0 feet. No groundwater was encountered.

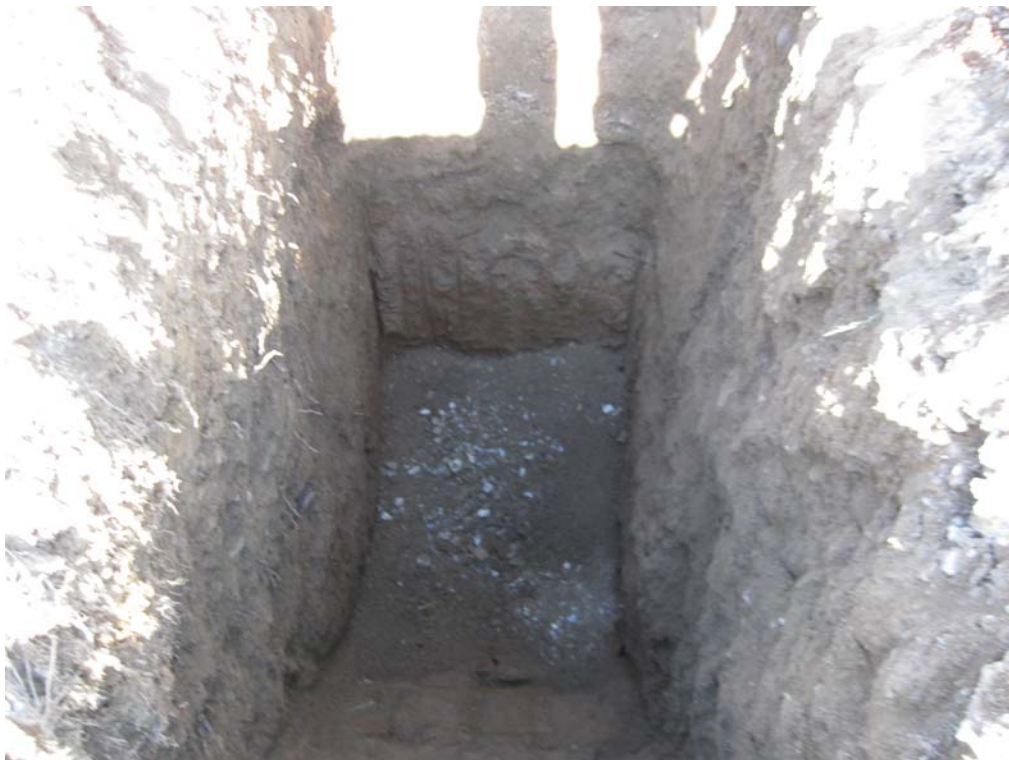
Photo 24 - TP-7 Soil Profile 6' BGS

The in-situ excavation revealed dry poorly-graded sand with silt and gravel to a depth of 3.0 feet, underlain by moist silty gravel to the bottom of the excavation at 7.0 feet. No groundwater was encountered.

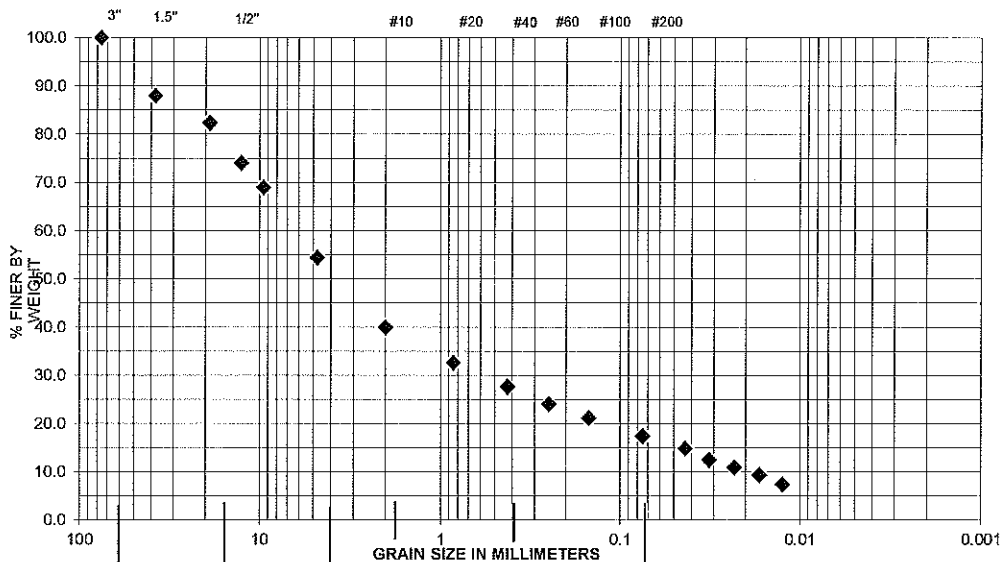
PARTICLE SIZE ANALYSIS ASTM D422/ C136

% GRAVEL:	45.6	USC:	GM
% SAND:	36.9	FC:	F2
% SILT/CLAY:	17.5	.02 mm:	10.2
ASTM D1557(uncorrected)		pcf	
ASTM D4718 (corrected)		pcf	
OPTIMUM M.C. % (corrected)			
NATURAL M.C. %		7.3

SIEVE SIZE (mm)	SIEVE SIZE (in.)	TOTAL % PASSING	SPEC
152.4	6"		
76.2	3"	100	
38.1	1.5"	88	
19.05	3/4"	82	
12.7	1/2"	74	
9.5	3/8"	69	
4.75	# 4	54	
2	#10	40	
0.85	#20	33	
0.425	#40	28	
0.25	# 60	24	
0.15	#100	21	
0.075	#200	17.5

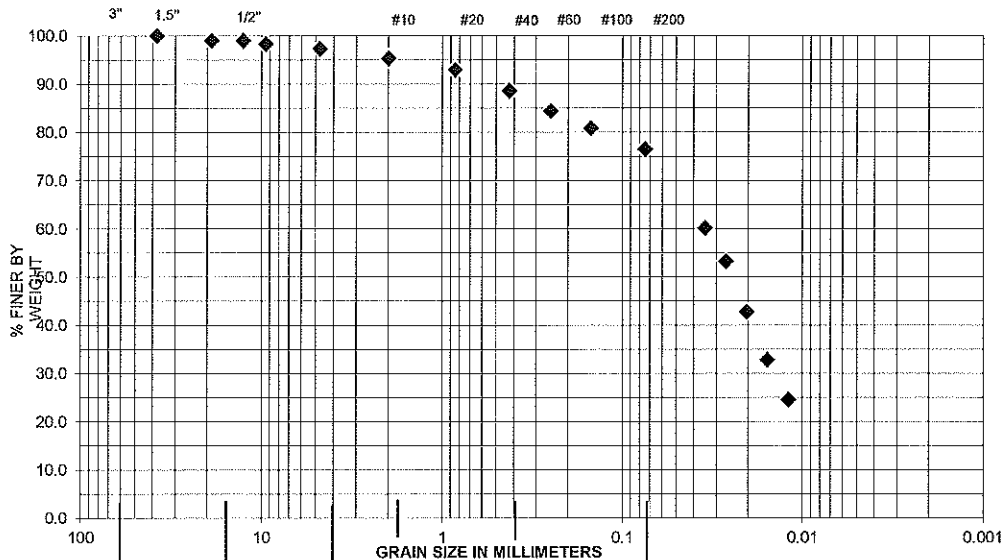
PARTICLE SIZE ANALYSIS ASTM D422/ C136

% GRAVEL:	2.6	USC:	ML
% SAND:	20.9	FC:	F4
% SILT/CLAY:	76.5	.02 mm:	42.1
ASTM D1557(uncorrected)			pcf
ASTM D4718 (corrected)			pcf
OPTIMUM M.C. % (corrected)			
NATURAL M.C. %			52.2

SIEVE SIZE (mm)	SIEVE SIZE (in.)	TOTAL % PASSING	SPEC
152.4	6"		
76.2	3"		
38.1	1.5"	100	
19.05	3/4"	99	
12.7	1/2"	99	
9.5	3/8"	98	
4.75	# 4	97	
2	#10	95	
0.85	#20	93	
0.425	#40	89	
0.25	#60	84	
0.15	#100	81	
0.075	#200	76.5

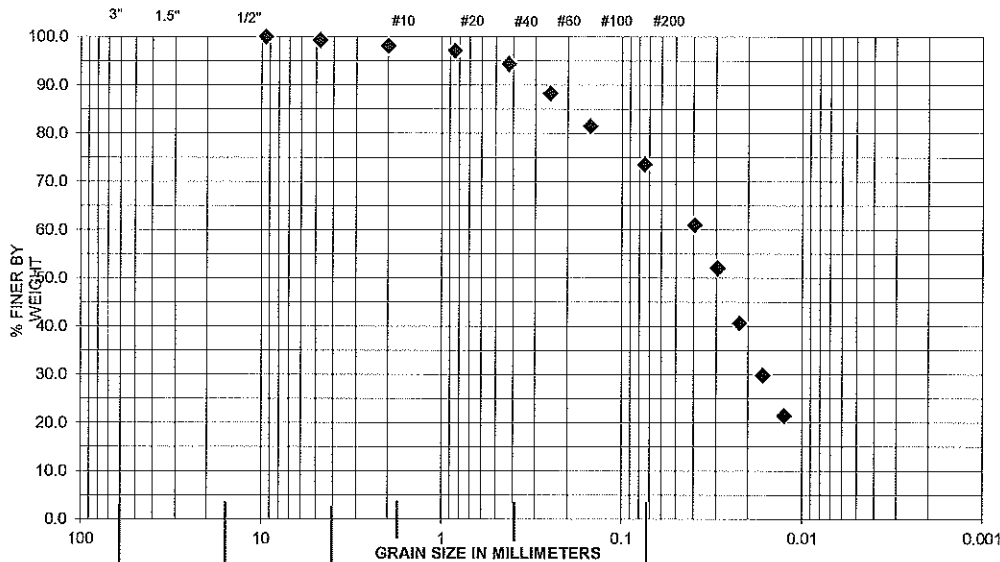
PARTICLE SIZE ANALYSIS ASTM D422/ C136

% GRAVEL:	0.7	USC:	ML
% SAND:	25.7	FC:	F4
% SILT/CLAY:	73.6	.02 mm:	36.7
ASTM D1557(uncorrected)			pcf
ASTM D4718 (corrected)			pcf
OPTIMUM M.C. % (corrected)			
NATURAL M.C. %			51.2

SIEVE SIZE (mm)	SIEVE SIZE (in.)	TOTAL % PASSING	SPEC
152.4	6"		
76.2	3"		
38.1	1.5"		
19.05	3/4"		
12.7	1/2"		
9.5	3/8"	100	
4.75	# 4	99	
2	#10	98	
0.85	#20	97	
0.425	#40	94	
0.25	# 60	88	
0.15	#100	82	
0.075	#200	73.6

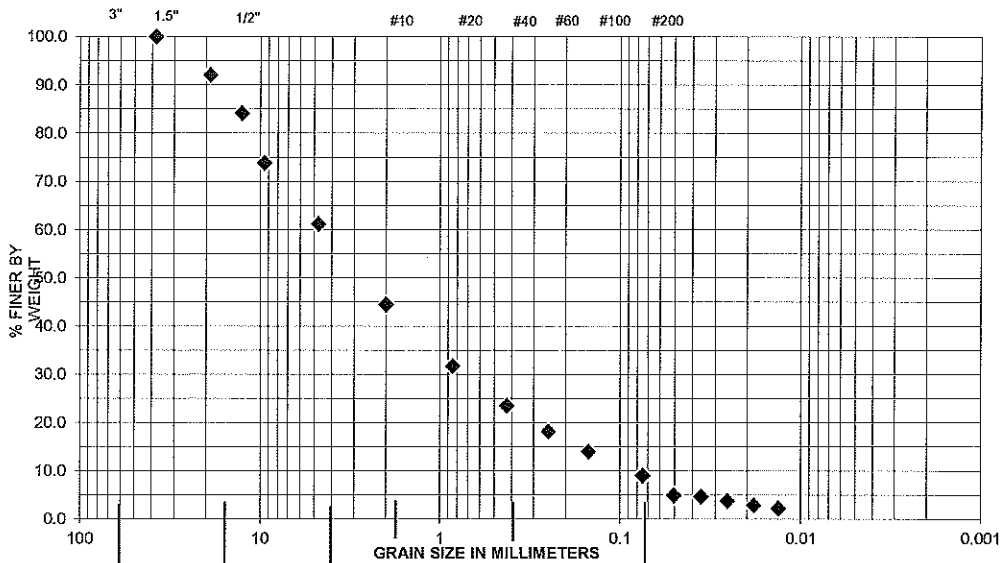
PARTICLE SIZE ANALYSIS ASTM D422/ C136

% GRAVEL:	38.8	USC:	SW-SM
% SAND:	52.2	FC:	S2
% SILT/CLAY:	9.0	.02 mm:	3.1
ASTM D1557(uncorrected)			pcf
ASTM D4718 (corrected)			pcf
OPTIMUM M.C. % (corrected)			
NATURAL M.C. %			4.2

SIEVE SIZE (mm)	SIEVE SIZE (in.)	TOTAL % PASSING	SPEC
152.4	6"		
76.2	3"		
38.1	1.5"	100	
19.05	3/4"	92	
12.7	1/2"	84	
9.5	3/8"	74	
4.75	# 4	61	
2	#10	45	
0.85	#20	32	
0.425	#40	23	
0.25	# 60	18	
0.15	#100	14	
0.075	#200	9.0

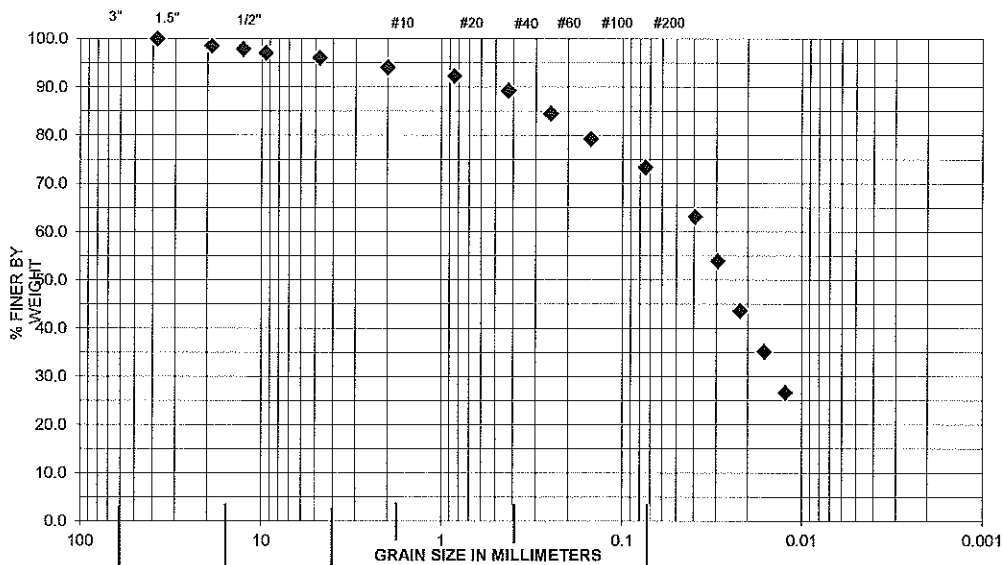
PARTICLE SIZE ANALYSIS ASTM D422/ C136

% GRAVEL:	3.9	USC:	ML
% SAND:	22.7	FC:	F4
% SILT/CLAY:	73.4	.02 mm:	40.9
ASTM D1557(uncorrected)			pcf
ASTM D4718 (corrected)			pcf
OPTIMUM M.C. % (corrected)			
NATURAL M.C. %			65.5

SIEVE SIZE (mm)	SIEVE SIZE (in.)	TOTAL % PASSING	SPEC
152.4	6"		
76.2	3"		
38.1	1.5"	100	
19.05	3/4"	99	
12.7	1/2"	98	
9.5	3/8"	97	
4.75	# 4	96	
2	#10	94	
0.85	#20	92	
0.425	#40	89	
0.25	# 60	85	
0.15	#100	79	
0.075	#200	73.4

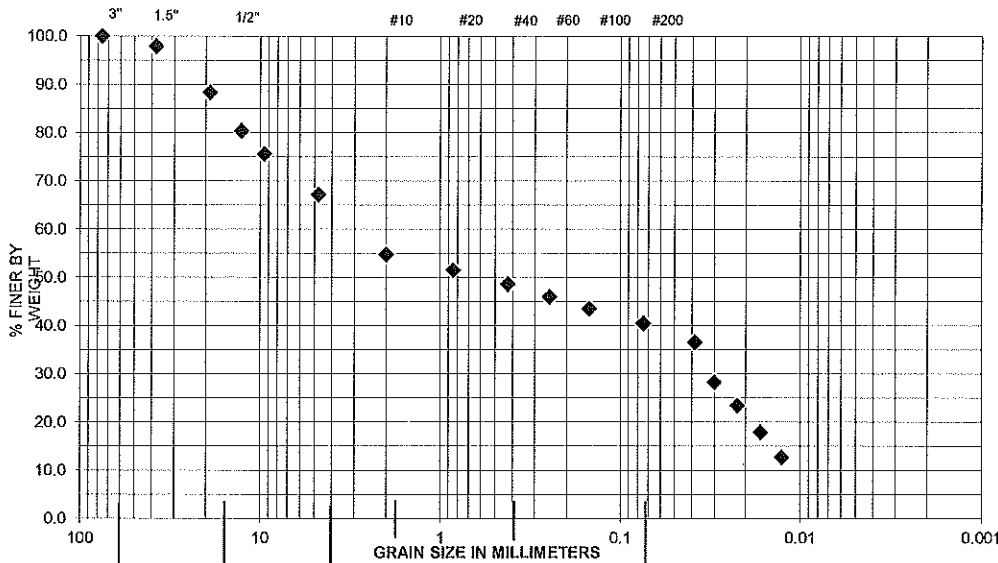
PARTICLE SIZE ANALYSIS ASTM D422/ C136

% GRAVEL:	32.8	USC:	GM
% SAND:	26.7	FC:	F3
% SILT/CLAY:	40.5	.02 mm:	21.4
ASTM D1557(uncorrected)		pcf	
ASTM D4718 (corrected)		pcf	
OPTIMUM M.C. % (corrected)			
NATURAL M.C. %		27.7

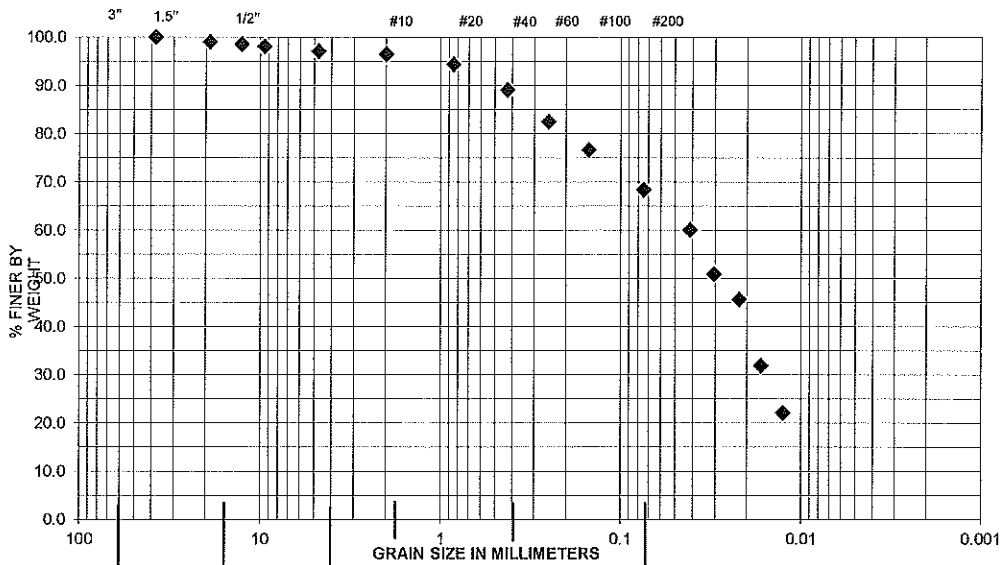
PARTICLE SIZE ANALYSIS ASTM D422/ C136

% GRAVEL:	2.9	USC:	ML
% SAND:	28.7	FC:	F4
% SILT/CLAY:	68.4	.02 mm:	40.7
ASTM D1557(uncorrected)			pcf
ASTM D4718 (corrected)			pcf
OPTIMUM M.C. % (corrected)			
NATURAL M.C. %			70.7

SIEVE SIZE (mm)	SIEVE SIZE (in.)	TOTAL % PASSING	SPEC
152.4	6"		
76.2	3"		
38.1	1.5"	100	
19.05	3/4"	99	
12.7	1/2"	99	
9.5	3/8"	98	
4.75	# 4	97	
2	#10	96	
0.85	#20	94	
0.425	#40	89	
0.25	# 60	83	
0.15	#100	77	
0.075	#200	68.4

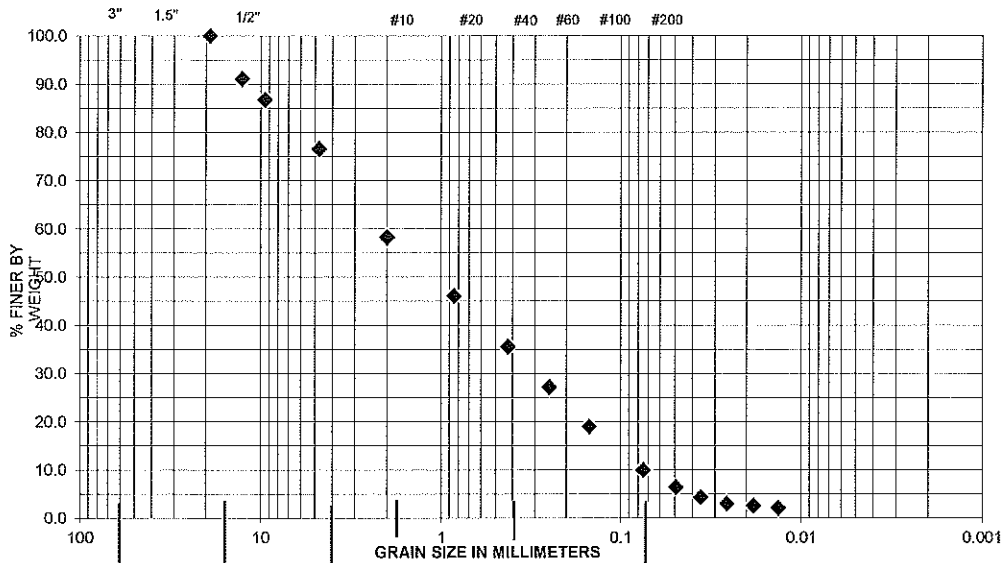
PARTICLE SIZE ANALYSIS ASTM D422/ C136

% GRAVEL:	23.4	USC:	SP-SM
% SAND:	66.6	FC:	PFS
% SILT/CLAY:	10.0	.02 mm:	2.7
ASTM D1557(uncorrected)			pcf
ASTM D4718 (corrected)			pcf
OPTIMUM M.C. % (corrected)			
NATURAL M.C. %			3.5

SIEVE SIZE (mm)	SIEVE SIZE (in.)	TOTAL % PASSING	SPEC
152.4	6"		
76.2	3"		
38.1	1.5"		
19.05	3/4"	100	
12.7	1/2"	91	
9.5	3/8"	87	
4.75	# 4	77	
2	#10	58	
0.85	#20	46	
0.425	#40	36	
0.25	# 60	27	
0.15	#100	19	
0.075	#200	10.0

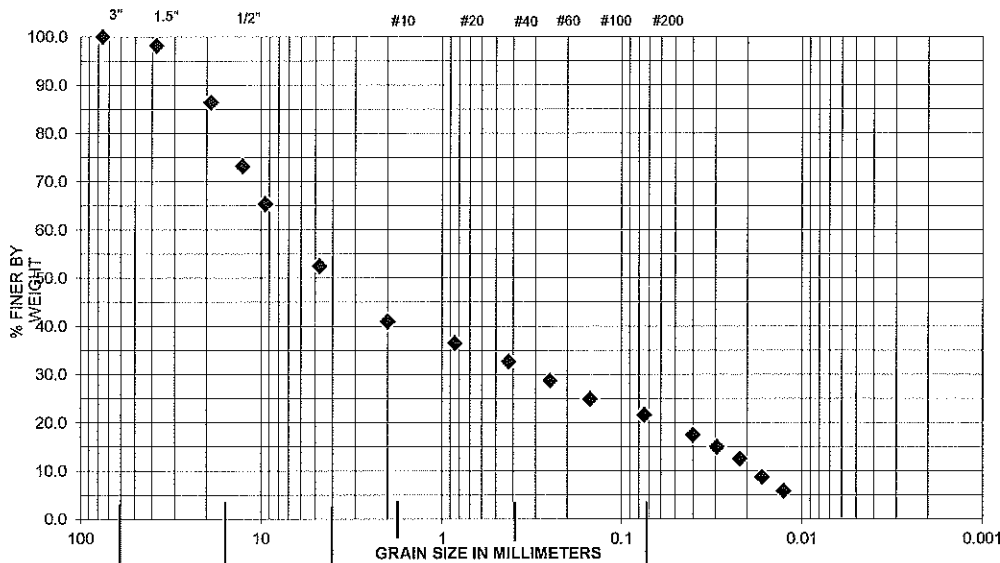
PARTICLE SIZE ANALYSIS ASTM D422/ C136

% GRAVEL:	47.5	USC:	GM
% SAND:	30.9	FC:	F2
% SILT/CLAY:	21.6	.02 mm:	11.2
ASTM D1557(uncorrected)		pcf	
ASTM D4718 (corrected)		pcf	
OPTIMUM M.C. % (corrected)			
NATURAL M.C. %		28.8

SIEVE SIZE (mm)	SIEVE SIZE (In.)	TOTAL % PASSING	SPEC
152.4	6"		
76.2	3"	100	
38.1	1.5"	98	
19.05	3/4"	86	
12.7	1/2"	73	
9.5	3/8"	65	
4.75	# 4	53	
2	#10	41	
0.85	#20	37	
0.425	#40	33	
0.25	# 60	29	
0.15	#100	25	
0.075	#200	21.6
